For Polaris Dealer and Distributor Service Departments

S-01-03

Subject

Recoil Housing Nut

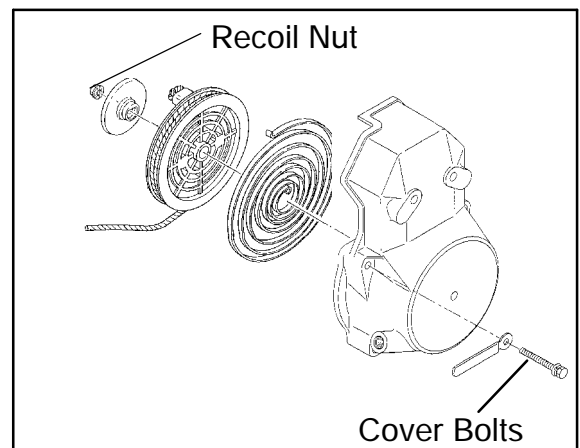
The recoil nut may come loose inside recoil assembly. Remove recoil housing and the retaining nut that holds recoil rope assembly, apply Loctite[®] 242 or 3-Bond 1342 to nut and re-torque to 49 in. lbs. (5.6 Nm). Reinstall recoil housing and torque cover bolts to 17-18 ft lbs (23-24.4 Nm).
