S-02-02

SERVICE BULLETIN

Edge[®] Reverse Chaincase Needs Cover Bracket

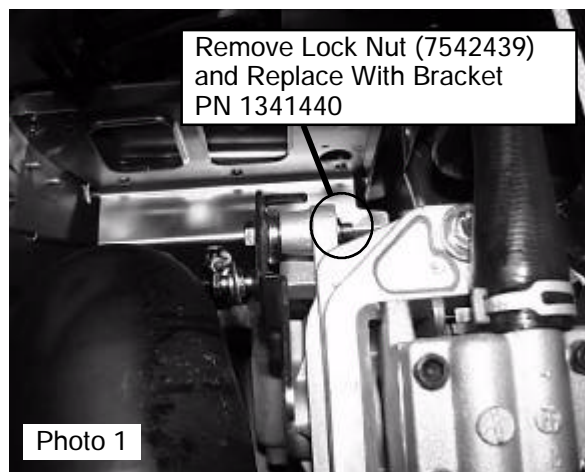
The possibility exists that the extended ear on the chaincase cover of all 2002 Edge[®] models with manual reverse may break due to deflection of the extended ear when shifting into or out of reverse. A bracket has been developed to add strength to the extended ear to reduce the possibility of breakage.

Replace the 3/8x24 lock nut PN 7542439 (photo 1) with bracket PN 1341440 which uses the chaincase for added strength. Re-assemble the shifting mechanisms and apply Loctite[®] 242 (blue) to the threads of the bolt. Tighten the bolt (PN 7515415) to 120 in. lbs. (13.56 Nm).
