SNOW TEAM TIPS

Published for Polaris Dealers, Distributors, and Service Staff

Vol. 11, No. 2

February, 2003

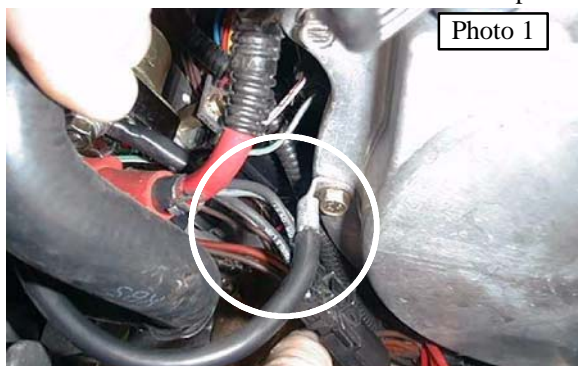
All 2002 and 2003 model year Frontiers need the fusible link secured properly. The fusible link may make contact with the ground strap, causing possible wear through and shorting the wire to ground (photo 1).

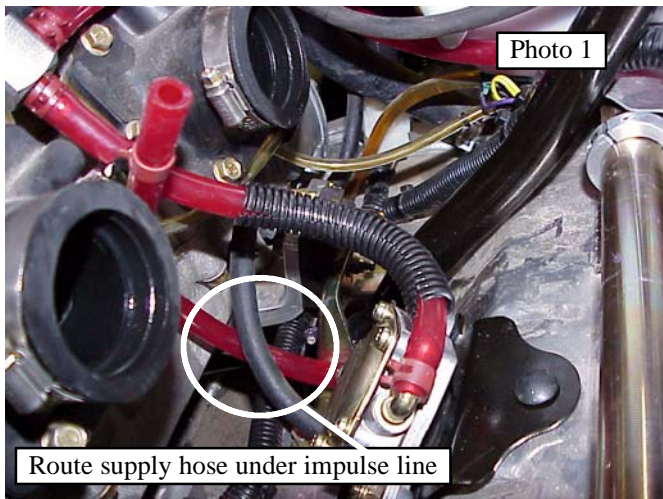
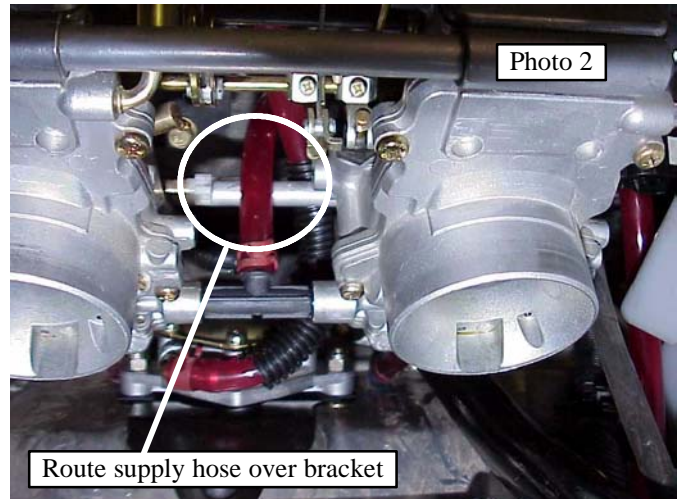
We have had some reports of the impulse line kinking after performing Service Bulletin S-03-04 (2003 700/800 RMK Fuel Pump Relocation). The possible cause of these kinks is fuel line routing. The fuel line must be routed underneath the impulse line as shown in photo 1. Make sure the "bend" in the impulse line follows its natural curvature.* Then route the line over the carb bracket as shown. Performing these steps should ensure the impulse line does not kink and starve the engine of fuel.

* Remove convolute tubing from impulse line if necessary to prevent kinking.

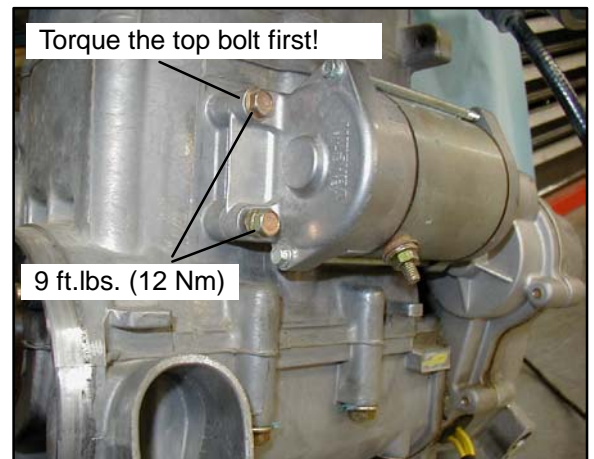
NOTE: It is important to tighten the top starter bolt first, the top hole acts as a pilot hole and this helps to properly align the starter drive (bendix) with the flywheel. This helps to prevent binding and starter damage.

Install the starter onto the engine case. Hand tighten each of the starter bolts. **Torque the top bolt first to 9 ft.lbs. (12 NM).** Then torque the bottom bolt to the same specification.
