SNOW TEAM TIPS

Published for Polaris Dealers, Distributors, and Service Staff

Vol. 11, No. 2

February, 2003

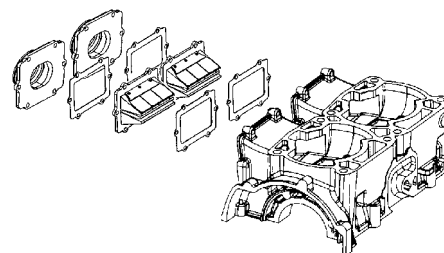
The 2003 440 PRO-X Liquid Parts Book was corrected to call out the **1202541- ASM-REED VALVE** and **2202497 - KIT-V FORCE REED REPLACEMENT**. The decision to go to V-force reed was made after initial October printing of the parts book. The Parts Book CD, which will correct the '03 parts book, will not be sent out to dealers until March. When ordering replacement reeds, make sure you order the correct part numbers.

1202541- ASM-REED VALVE

2202497 - KIT-V FORCE REED REPLACEMENT
